The environment effect on operation of in-vessel mirrors for plasma diagnostics in fusion devices

V.S. Voitsenya, Ch. Gil, V.G. Konovalov, A. Litnovsky, M. Lipa, M. Rubel,
A. Sagara, A. Sakasai, B. Schunke, T. Sugie, et al.

THE ENVIRONMENT EFFECT ON OPERATION OF IN-VESSEL MIRRORS FOR PLASMA DIAGNOSTICS IN FUSION DEVICES

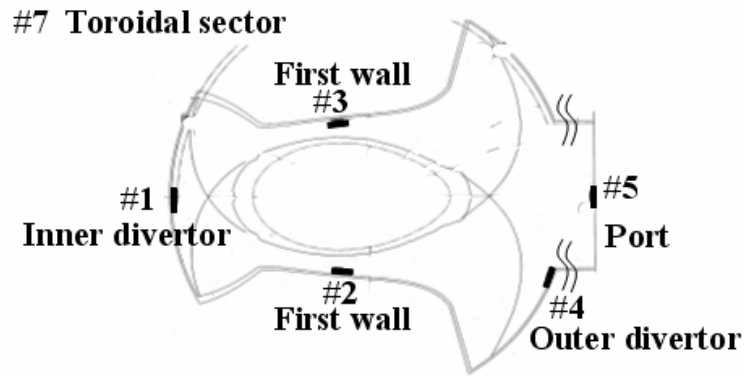
Fig. 1. The scheme of locations of SS mirror samples inside the LHD vessel.

Three SS mirrors with size 20x10x1 mm were mechanically polished, cleansed in an ultrasonic bath filled with acetone, and then the spectral reflectance at normal incidence was measured in the wavelength range 200-700 nm. The samples were installed inside the LHD vacuum vessel in locations indicated in Fig. 1 by numbers 1, 3, and 5: the sample #1 was positioned near the divertor region, #3 – close the plasma edge, and #5 – quite deeply in the diagnostic port in the same poloidal cross section and in the same plane as #1 (central plane). After samples were removed the reflectance was again measured in the same way, and the surface of samples were analyzed by several methods: Auger electron spectroscopy (AES), ion backscattering technique (RBS) using 1.5 MeV He^+ ion beam, scanning electron microscopy (SEM), profilometry, and ellipsometry at the wavelength 632.8 nm. These data are presented in detail in [4].

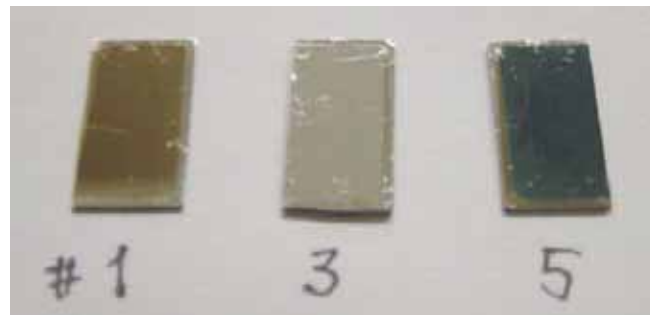
Fig. 2. The photos of samples after they were taken out of the LHD vacuum chamber.

The photos of Fig. 2 show how mirror samples looked just after finishing their exposure in LHD vacuum vessel. As a result of exposure in LHD the reflectance of all samples has changed from the identical initial level, Fig. 3.

The reflectance of mirrors #1 and #5 dropped strongly as a result of appearance of the contaminating films. From spectral dependence of reflectance one can conclude that the film on sample #5 is thicker than on the #1 sample. At the same time, the reflectance of sample #3 increased significantly and became close to what is usually observed when after rinsing in a

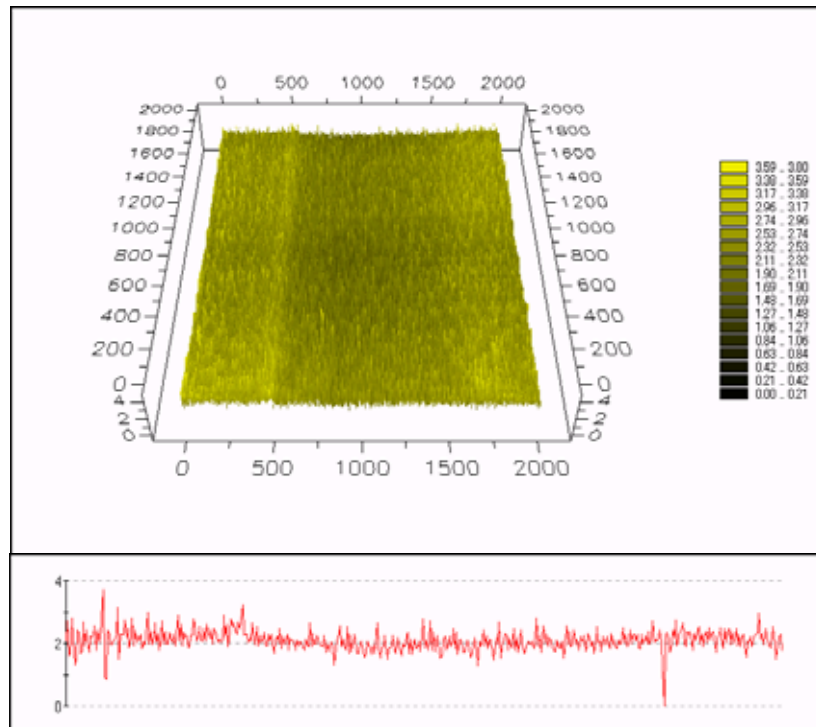
Fig. 4. Results of profilometry measurement of the surface morphology of the sample #3 after exposing in the LHD.

After rinsing in the ultrasonic bath the samples are cleaned by low temperature plasma of an ECH discharge in deuterium, as shown by solid points (the curve “standard”). This effect is connected with not full cleaning of all three mirrors before they were installed inside the LHD vessel from contamination by some organic film appeared due to rinsing samples in acetone. This initially existed film was fully cleaned from sample #3 due to plasma impact but became over coated by new films (to be immured) at samples #1 and #5. The high level of reflectance for mirror sample #3 measured after exposure samples in LHD was supported by very high quality of surface as follows from profilometry measurements (Fig. 4) and analysis of the SEM photos (not shown).

The mirror placed in the nearest location to the hot plasma became to be cleaner than it was initially. The full erosion of this sample found by measurement of the surface profile did not exceed $0.15\mu\text{m}$. Such small net erosion seems surprising if one takes into account the long time of glow discharge conditioning and large number of working discharges. Probably the balance between sputtering by CXA during working discharges and by plasma ions during conditioning, on the one side, and contaminant deposition, on the other side, was almost zero, only with minor preponderance of sputtering erosion over deposition.

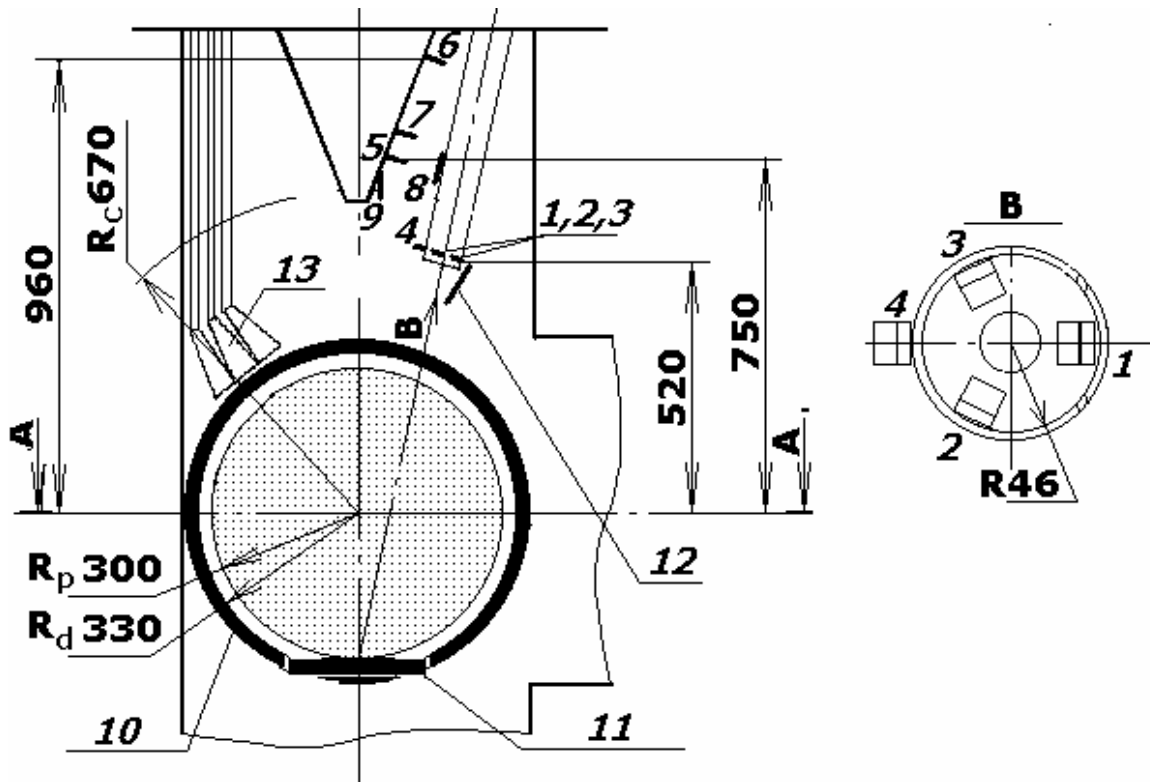
Fig. 5. The layout of experiments in T-10.

1-9 – mirrors (note, mirror #7 is in the shade of mirror #5), 10 - ring carbon based limiter, 11 - movable graphite limiter, 12 - shutter, 13 – ECRH antenna. R_c – radius of toroidal magnetic coils; R_p – plasma radius; R_d – radius of ring limiter.

Polished mirror samples of SS316 (10×10 mm² and 20×20 mm², 4 mm thick) were used for experiments. They were exposed in diagnostic port of limiter section of T-10 at different distances from plasma as shown in Fig. 5 [6].

Thin SS shield protected a part of each sample with ~ 0.1 mm gap between shield and mirror surface. Samples fixed in 1-3 positions were shutter-protected during vacuum vessel (VV) conditioning. The positions of mirrors 1-6 were frontal to plasma. Besides, in 2003 mirrors 8-9 were placed edgewise to plasma and one mirror located in frontal position, 7, was shadowed by sample 5.

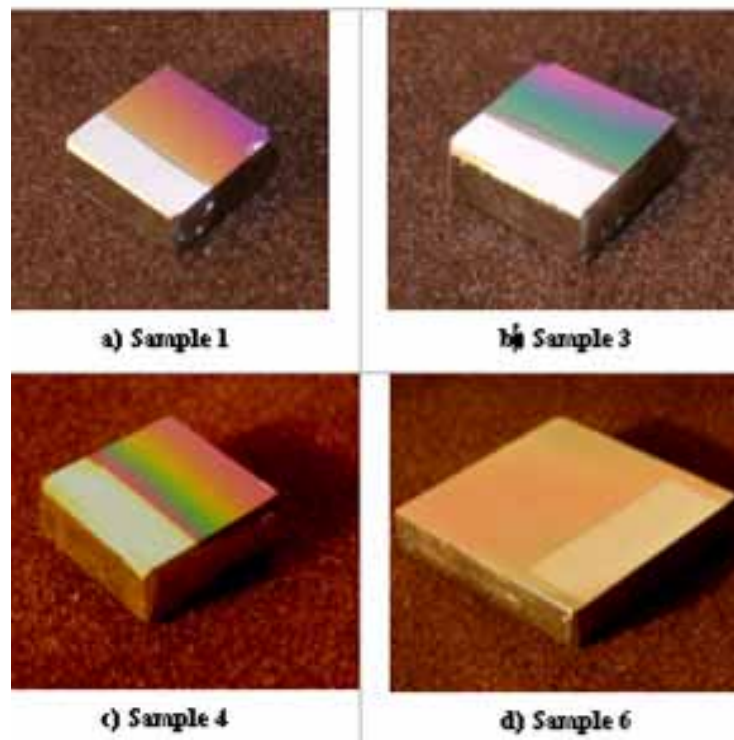
Fig. 6. Photos of samples after finishing the 2002 year campaign. Lighter parts of mirrors were closed during whole exposure time. The deposit has quite homogenous, fine-dispersed structure. On mirrors protected by shutter during conditioning it grew with the rate 0.2 nm/s in 2002 and 4 nm/s in 2003.

looked shining and smooth and the color of deposits varied from golden-crimson to violet-green. The screened parts of mirrors practically did not changed by sight, Fig. 6. The deposits not only decrease the reflectance of mirrors but also distort the spectrum of reflected radiation because of interference phenomenon.

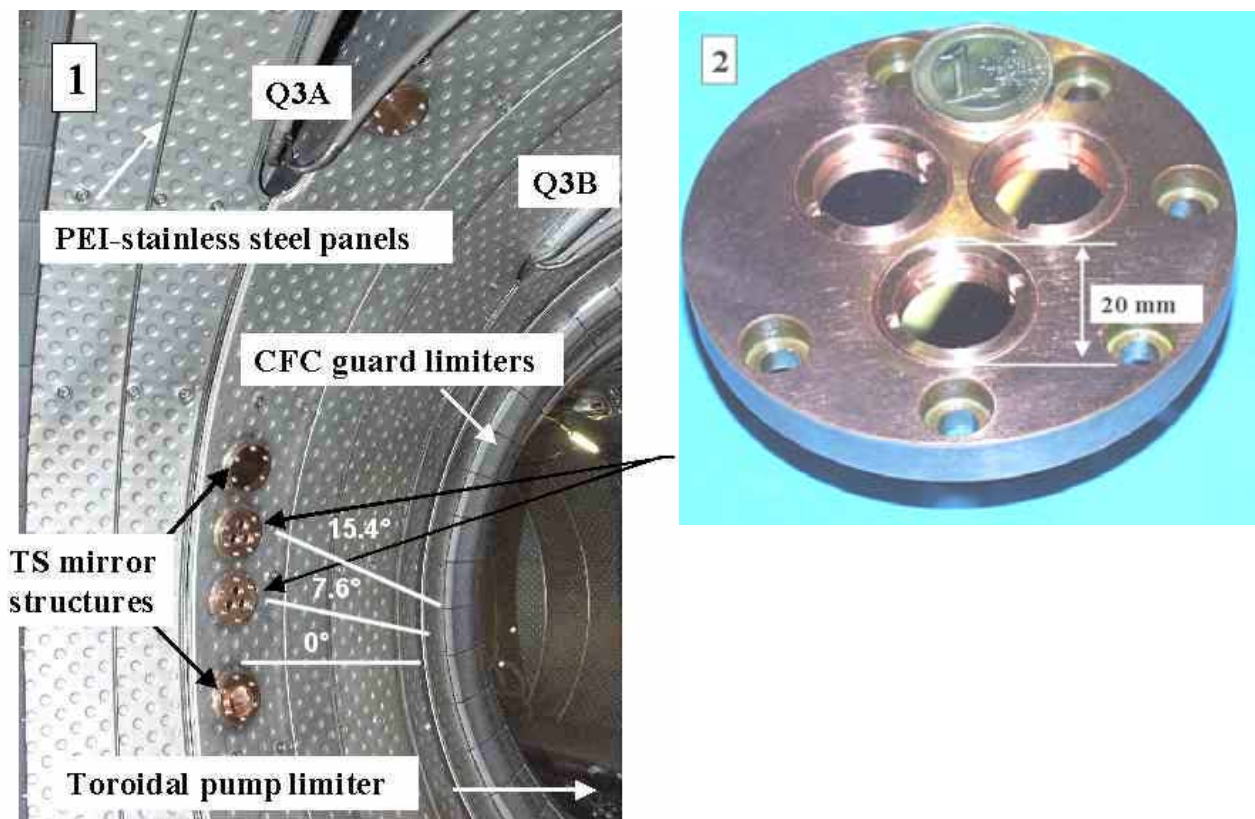
Fig. 7. Mo, SS and Cu mirror samples assembled in CuCrZr ring holders and fixed on Tore Supra vessel wall at high field side.

The mirror samples of 22 mm diameter and 4 mm thickness have been installed on the high field side of the TS plasma vessel. They were located at $\theta = 7.5^\circ$ and 15° out of the equatorial plane (Fig. 7) and positioned roughly 140 mm from the LCFS. The reflecting surface of all mirrors were oriented parallel (not inclined) to the toroidal field direction. The mirror assembly allowed contact cooling via the first wall steel panels. 2D- thermohydraulic finite element calculations of the mirror sample assembly showed temperatures not exceeding $\sim 150^\circ\text{C}$ for a typical “Gigajoule” operation scenario (~ 1 MW radiated plasma power loss during 36 s of pulse length).

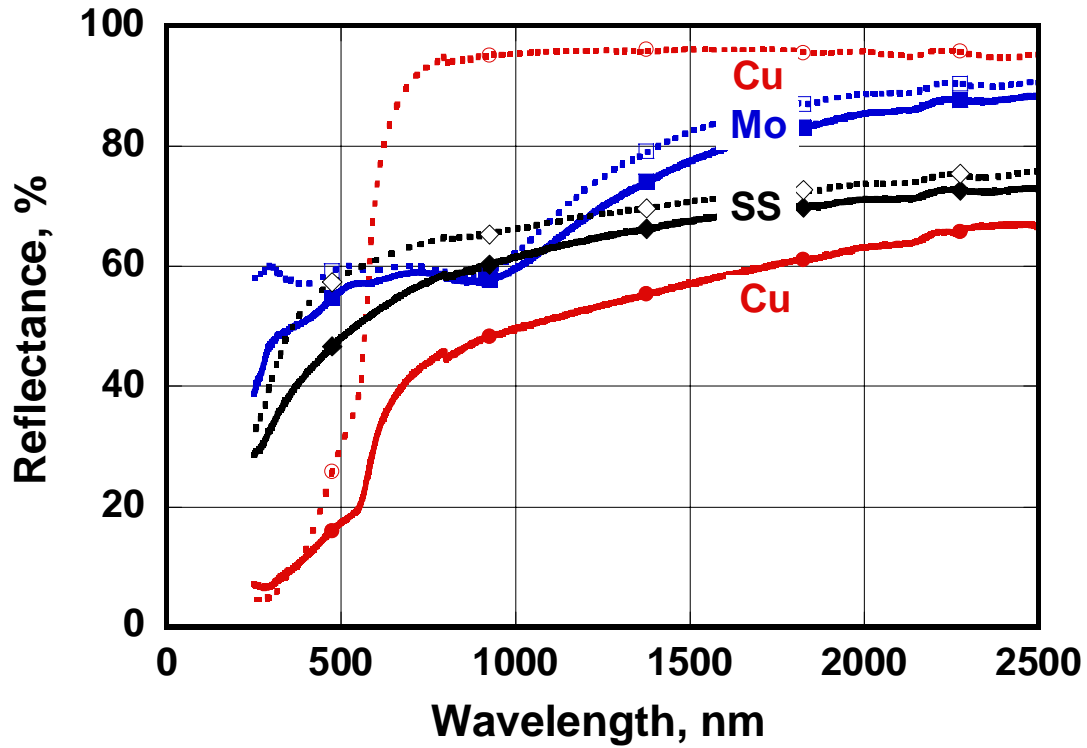
Fig. 8. Reflectance of mirror samples before (doted lines) and after (solid lines) exposure inside Tore Supra.

Total and diffusive reflectance values were measured before and after exposure in the Tore Supra tokamak by means of a spectrophotometer ($\lambda=250-2500$ nm) and significant change of reflectance was observed for all samples, but especially for Cu, as Fig. 8 shows. From measurements by con-focal microscopy the surface roughness of the Cu mirror samples after exposure increased by factor 7 and a net erosion profile depth amounted $\sim 2.8 \mu\text{m}$, while the surface roughness of the sc Mo samples did not change with a net erosion profile depth only $\sim 0.12 \mu\text{m}$.

It was found that all exposed mirror samples became not only eroded but also coated with some deposited layers what is the main reason for change of the total reflectance.

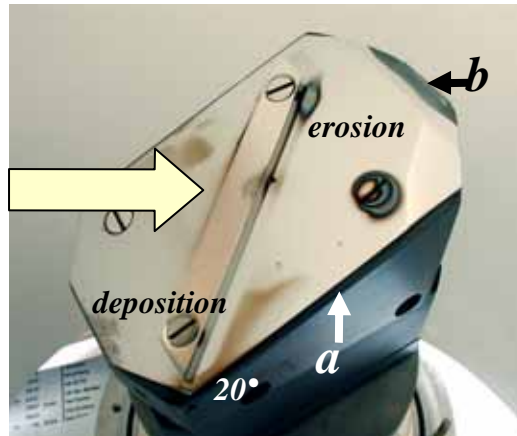
Fig. 9. Photograph of the mirror holder after exposure in the erosion dominated zone. The large mirror (a) is mounted 20° inclined on the graphite carrier, the small mirror (b) on the rear side perpendicular to the toroidal direction.

Polycrystalline mirrors from molybdenum were placed in the SOL plasma of TEXTOR [10]. The photograph in Fig. 9 shows the experimental set-up and the appearance of mirrors after exposure. One large mirror (115mm x 74mm) was fixed inclined at 20° to the toroidal fluxes. The mirror was partly protected by an aluminium bar which created a shadow. Outside the shadow some deposition becomes visible. One small mirror was placed for comparison at the rear side of the holder perpendicular to the toroidal direction. All mirrors were polished mechanically and had optically been pre-characterized.

In the first experiment the edge of the mirror closest to the plasma was kept at a distance of 8 mm from the LCFS (plasma radius 46 cm) which is an erosion dominated zone in TEXTOR. It was exposed to 30 neutral beam heated (increasing from zero up to 1.3 MW) plasma pulses (line averaged density $n_e = 1.5 \times 10^{19} \text{ m}^{-3}$) with a total exposure time of 197 s. These conditions caused strong temperature rises ($>1000^\circ\text{C}$ for $\approx 3\text{s}$) of the edge of the small mirror. The temperature of the large mirror measured by a pyrometer rose to 400-750 $^\circ\text{C}$ during the discharges. For the second experiment the closest edge of the mirrors to the plasma were placed at LCFS+25mm to cover primarily the deposition dominated zone. They were exposed to 58 (partially neutral beam heated) discharges with varying plasma density ($n_e = 1.5$ to $4.5 \times 10^{19} \text{ m}^{-3}$) and a total exposure time of 312 s. The bulk temperature achieved 150 $^\circ\text{C}$, local temperature rises have not been observed. Carbon deposition up to thicknesses of more than 200 nm took place except in

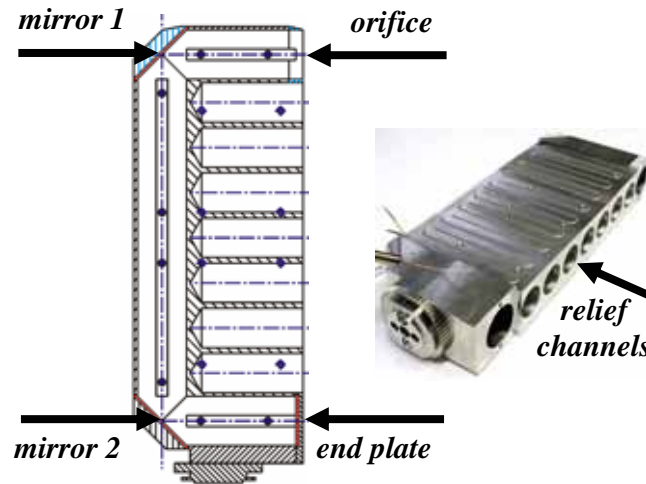
Fig. 10. Periscope system with mirror 1 (closest to the plasma), mirror 2 and the end plate. The tubes (35mm) are wrapped inside with exchangeable steel foils fixed at the wall by bars. The photograph shows the stainless steel body without end plate. Relief channels reduce weight.

The set-up of a periscope-like system on TEXTOR simulates the ITER diagnostic ports transmitting the plasma radiation to further distant sensors. Two plane mirrors were installed in tubes facing each other at a distance of 275 mm. The mirrors are oriented 45° with respect to the line of sight. The orifice (35 mm diameter) is oriented perpendicular to the toroidal direction.

The second end was closed with a polished end plate as is shown in Fig. 10. The SOL fluxes hit the first mirror under 45°. Carbon transport inside and deposition can be investigated after dismantling of the system. The deposition patterns on exchangeable steel foils wrapped inside the tubes complete this information. The stainless steel body can be heated up to about 500°C. Mirrors made from TZM (99% Mo, 0.1% Zr, 0.5% Ti) were used for the pilot experiment. The edge closest to the plasma was kept at 25 mm from the LCFS and the system exposed to 89 (partly neutral beam heated) plasma pulses ($n_e = 1.5$ to $4.5 \times 10^{19} \text{ m}^{-3}$) with a total plasma exposure time of 1047 s. The temperature was 150 °C.

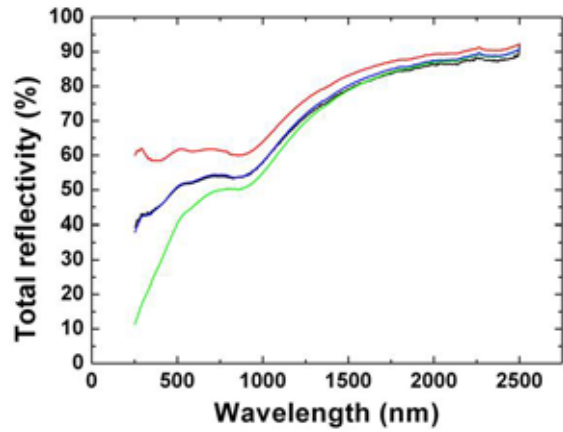
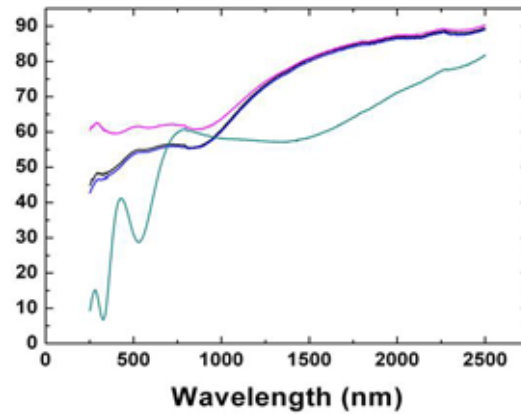
Fig. 11. Total reflectivity R_{tot} depending on wavelength measured on the molybdenum mirrors before and after exposure in a protected area (1) and after exposure in the deposition (2) and erosion (3) area. The mirrors (a) were exposed for 197 s in the erosion dominated zone (edge at LCFS+8mm) and (b) and for 312 s in the deposition dominated zone (edge at LCFS+25mm).

space resolution of ≈ 10 mm. Fig.11 shows examples for the wavelength dependence of the total reflectivity R_{tot} found on the two large mirrors. The central curves (1) represent the total reflectivity measured before and after plasma exposure at a location protected by the aluminum bar. The lines stay below the values given for polycrystalline molybdenum in literature [11]. As soon as deposition begins (curve 2 in Fig.11a) the reflectivity decreases by absorption in the film (thickness ≈ 30 nm). The drop is most pronounced in the UV region and levels off in the IR. In addition to absorption, the reflectivity can be distorted significantly due to destructive and constructive interference in thicker deposits. The example (curve 2, Fig. 11b) was measured on the mirror plate exposed deeper into the SOL (LCFS+25mm) where carbon deposition dominates and a film up to about 220 nm thickness was formed.

Surprisingly, an increase of R_{tot} was measured on surface areas which suffered from net erosion (curves 3). The increases are similar, independent whether the target mirror was exposed near the plasma edge (Fig. 11a) or deeper into the SOL (Fig. 11b). This increase is most pronounced ($\Delta R_{\text{tot}} \approx 10\text{-}20\%$) for short wavelengths and almost vanishes (1-3%) beyond about 1500 nm.

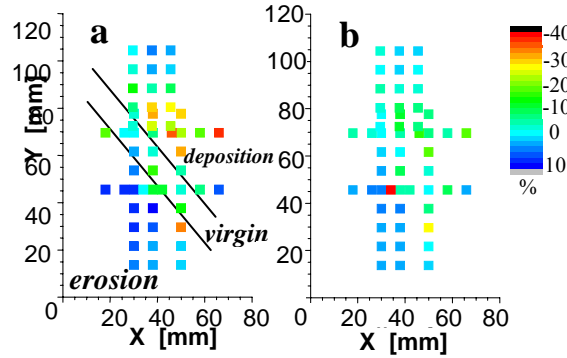
Fig. 12. Differences $\Delta R_{\text{tot}} = R_{\text{after}} - R_{\text{before}}$ given in colours at different surface locations for $\lambda=250$ nm (a) and 500nm (b). The co-ordinates x and y cover the mirror dimension (74mm x 115mm).

exposure the local changes were much larger. Fig. 12 shows the N differences $\Delta R_{\text{tot}} = R_{\text{after}} - R_{\text{before}}$ measured on the mirror exposed at LCFS+8mm. The differences are highest for $\lambda=250$ nm (a) and achieve more than +12% (dark blue) in the eroded part of the mirror, while reductions of -30% (deep red) occur in areas covered with deposits. In protected or shadowed areas ΔR_{tot} is in the scatter range ΔR observed before exposure (blue green). For increasing wave lengths (b) the changes are less pronounced. The intensity of the diffuse reflected light has also been measured at the identical locations, but contributes little since the differences do not exceed about $\pm 2\%$ on this mirror plate.

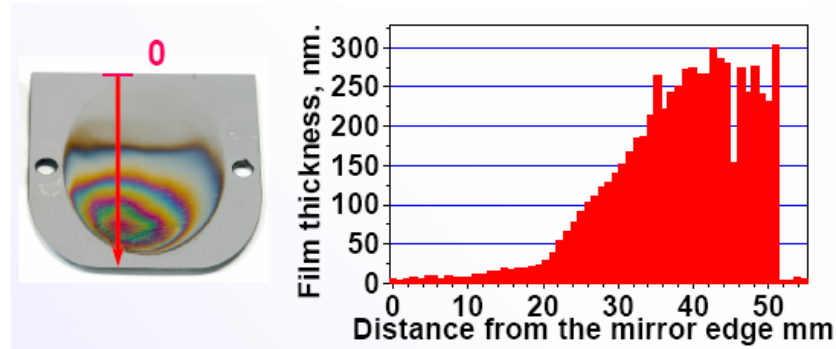
Fig. 13. The thickness of carbon-based film deposited on the mirror #1 of the periscope system.

Mirror #1 exposed in the periscope for 1047 s showed a radial decaying deposit with a maximum thickness of about 300 nm, Fig. 13, as follows from electron probe micro-analysis (EPMA). The thickness corresponds to a deposition rate of about 0.4 nm/s (inclination angle 45°). Although the deposition rate on mirror 1 is high, no detectable deposition was found on the following mirrors and walls.

The deposition rate of ≈ 0.4 nm/s on mirror #1 (inclination angle 45°) in the periscope is less than found on the 20° inclined mirror (0.7 nm/s) at the comparable radial position. This might partly be due to the fact that roughly one half of the carbon entering the orifice becomes deposited on the inner tube wall, visible there as a transparent deposit. Part of the carbon will likely be re-eroded from mirror #1. It is surprising therefore that no further deposition could be detected on the following walls and mirrors. One reason could be that the exposure time of 1047s is too short to grow a detectable layer. Another reason might be the pressure built up in the closed system which prevents the hydrocarbon radicals to penetrate deeper. Enhanced re-erosion of freshly formed deposits [15] may also play a role.

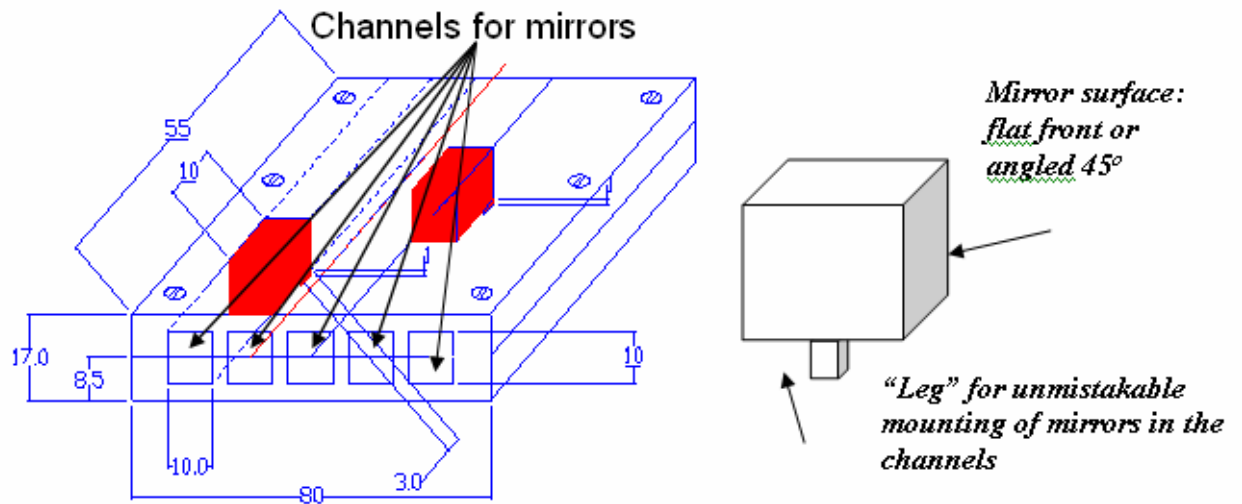
Fig. 15. A schematic view of a cassette and a mirror block for the test in JET.

Fig. 15 exemplifies a design of a stainless steel cassette with several channels in which the mirrors are mounted. The number of channels in a cassette, three or five, is dependent on the

The cassettes are of a “pan-pipes” shape and they are composed of two detachable plates. The construction enables studies of deposition both inside the pan-pipes channels and on the mirror surfaces. Moreover, the exposure of mirror surfaces at various inclination angles and aspect ratio with respect to plasma is possible. Effects of sample temperature on deposition in the divertor may be studied by comparison with the QMB data [16]. Figures 15 a-c show the location of mirrors and other deposition monitors in the divertor base and the inner carrier. The arrangement of devices in the outer divertor is similar to that in the inner leg (see Fig. 15 d). There are also cassettes placed on the main chamber wall (Fig. 16) protected by magnetic shutters which open when the magnetic field is on. This ensures avoiding the deposition of beryllium during its evaporation on the JET wall. Installation of all the deposition monitoring devices in the JET vessel is compatible with remote handling [17]. The construction phase and commissioning of the diagnostic tools for TRS (including FMT) is to be ready for installation in 2004. The experiment itself will be carried out in 2005 until the next opening of the JET vessel.

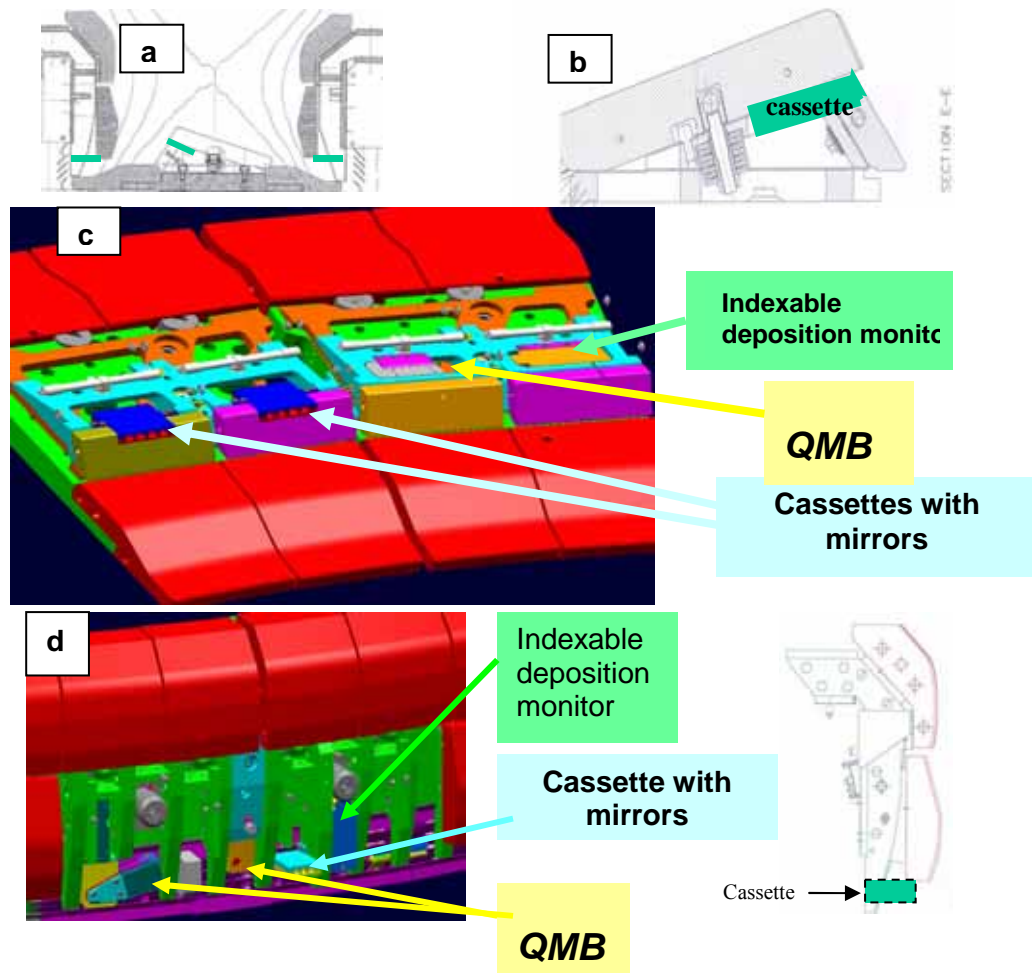
Fig. 16. (a) Divertor cross-section with a mirror cassettes (green boxes) in the inner, the outer carrier and below the load bearing plate (LBP made of carbon fibre composite); (b) base divertor module with a cassette; (c) location of several devices for monitoring the deposition mounted in the base divertor modules [Load Bearing Plate is removed]; (d) location of tested mirror and other deposition monitors in the inner divertor.
